Performance of Roads and Bridges During the December 22, 2003 M6.5 San Simeon Earthquake

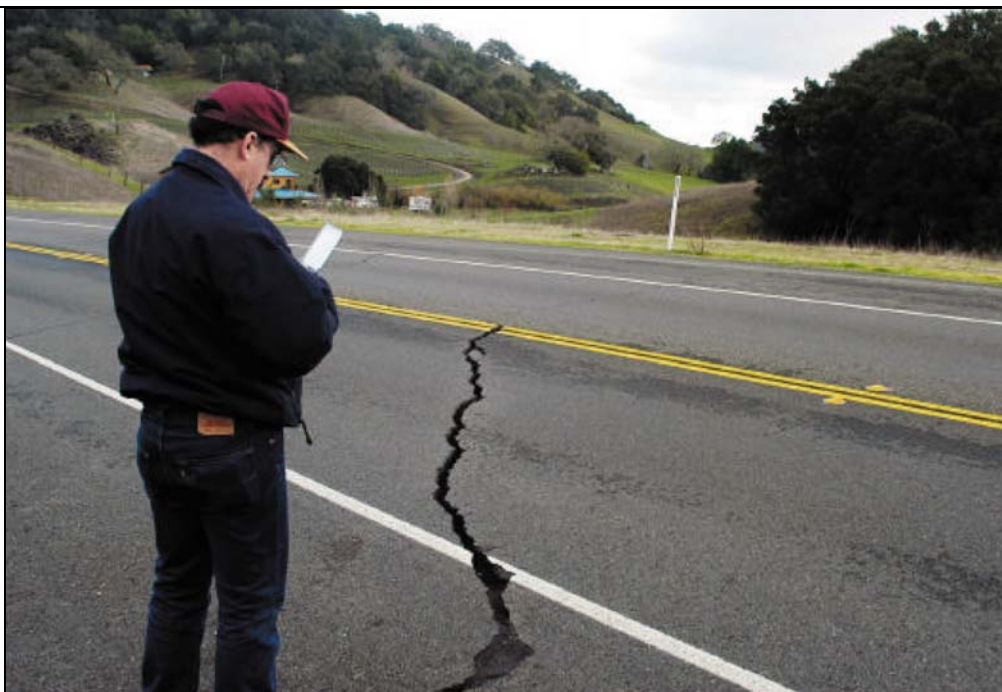
Lew Rosenberg (San Luis Obispo County Geologist) standing in front of damage to Highway 46.

The most significant road damage was to State Routes 41 and 46 between I-101 and I-1. Ron Richman, the District 5 geotechnical engineer writes, *"We observed rock falls originating from cut slopes on Route 41. The Route 46 damage included surging of landslides, spreading of tall embankments and fissuring at the contacts between the original ground and tall embankments. We did not observe significant effects on the bridges in the region. We looked for indications of liquefaction, but found none."* This damage was sufficient to keep Caltrans busy with repairs.

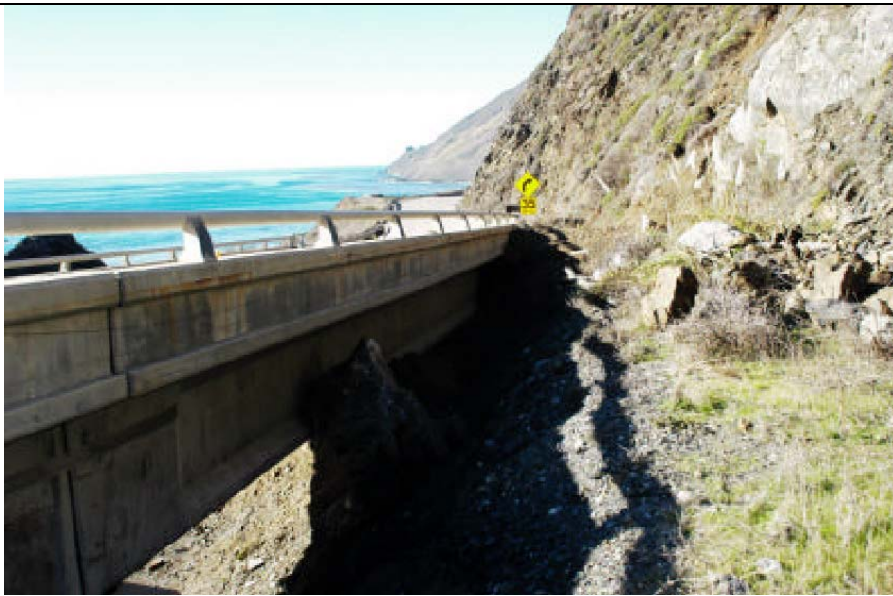
Villa Creek (State) Bridge (44 0028) in Monterey County.

Villa Creek Bridge, seven miles north of San Luis Obispo County, was the only Caltrans structure that was damaged during the earthquake. This is a five simple-span, precast girder structure on Highway 1, along the Pacific coast. The deck is supported on tall single column bents. The bridge was recently retrofit, which didn't protect it from a rockslide that put a hole in the northeast girder web. However, this damage did not reduce the girder's ability to carry traffic and the bridge remained open following the earthquake.

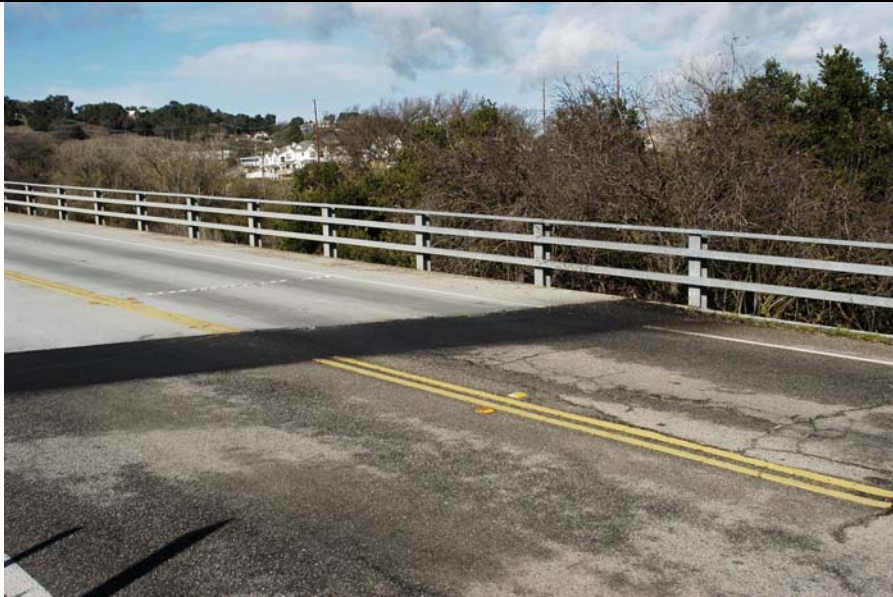
Templeton Road (County) Bridge (49C 0177) less than a mile east of I-101 in San Luis Obispo County.

The Templeton Road Bridge spans over the Union Pacific RR and the Salinas River. The west two spans are CIP girders and the east five spans are RC box girders. The superstructure is on flared, single column bents with piles and on seat and end diaphragm abutments on spread footings. The bridge was not retrofit. Most of the damage was due to liquefaction, settlement, and shaking of the superstructure. The approaches settled about 5 inches. The barrier rail and utility lines were also damaged. Soil borings were taken before a chip seal was placed at the approaches.

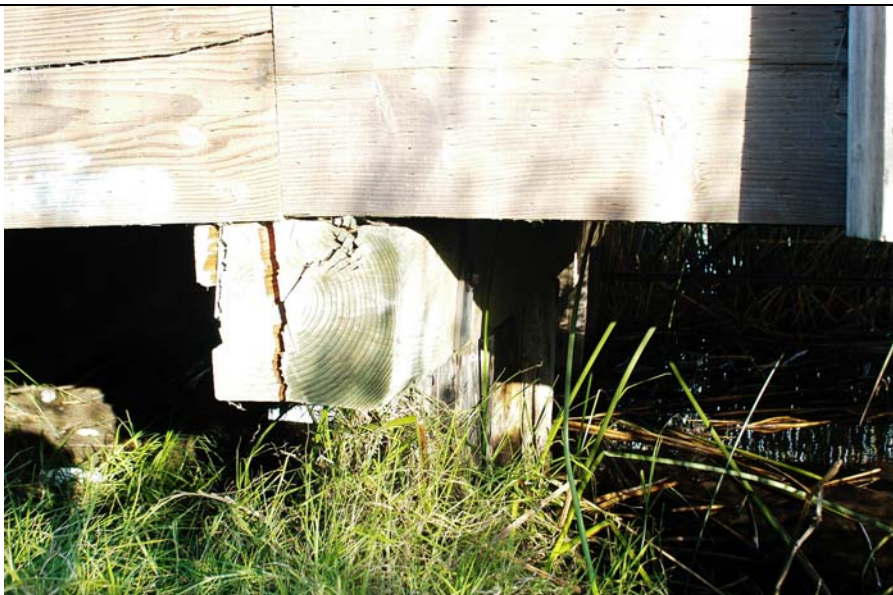
Lakeside Ave (County) Bridge (49C 0126) in Oceano.

A lagoon in Oceano frequently floods its banks. The town was built on the loose, saturated alluvium carried by these floods.

This soil liquefied during the earthquake causing considerable damage. There are three timber trestle bridges that cross over the lagoon and they were all damaged due to lateral spreading. The seat-type abutments moved toward the lagoon cracking the timber stringers and splitting the timber bent caps. These bridges look fairly new and the lumber appears to have been recently purchased.
